CARLO GAVAZZI SPACE SpA	<h1>AMS02-PDS</h1>	N° Doc: PDS-RP-CGS-120 Doc N°:	
	PDS-PFM THERMAL VACUUM TEST REPORT	Ediz.: 1 Issue:	Data: SEPT 2009 Date:
		Pagina 27 Page	di 29 of

<p>SERMS</p> <p>Laboratorio per lo Studio degli Effetti delle Radiazioni sui Materiali per lo Spazio</p> <p>Via Pentima Bassa, 21 Terni 05100 TR phone/fax: +39.0744.49.29.13</p>	<p>ENVIRONMENTAL TEST REPORT</p>	<p>doc: PDS TVT date: 07/09/09 rev: A02 pag: 1 /39 file: ENVRPT149_S2413R-A02-07SEP2K9</p>
--------------------------------------------------------------------------------------------------------------------------------------------------------------------------------------------------	---------------------------------------------	------------------------------------------------------------------------------------------------------------

The AMS-02 Power Distribution System Flight Model (PDS-PFM)

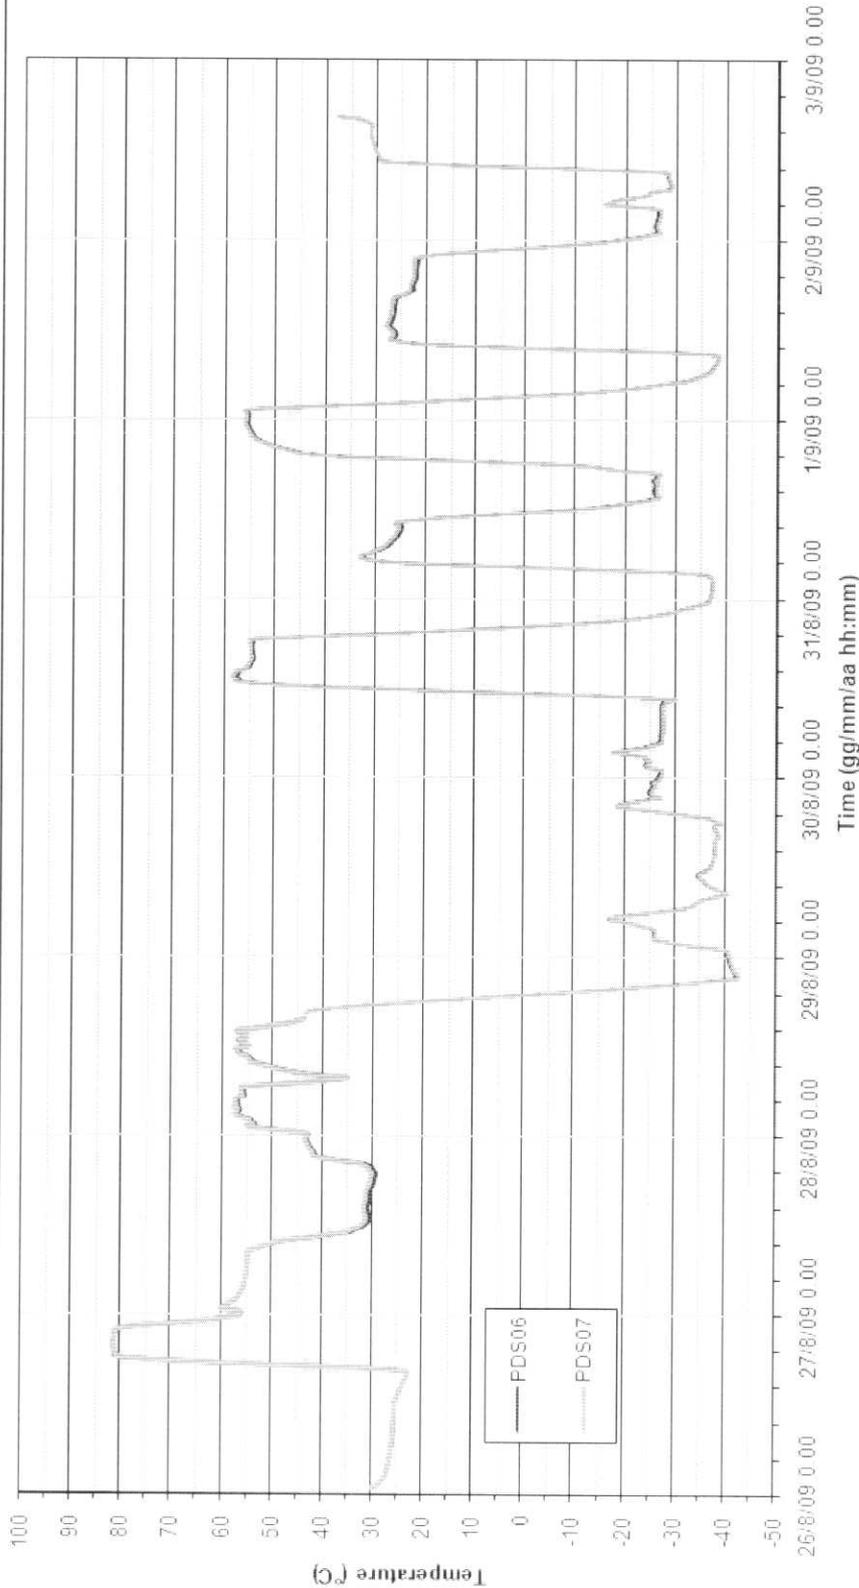
FIGURE 37 – PDS-BUS B TRP TEMPERATURE PROFILE.

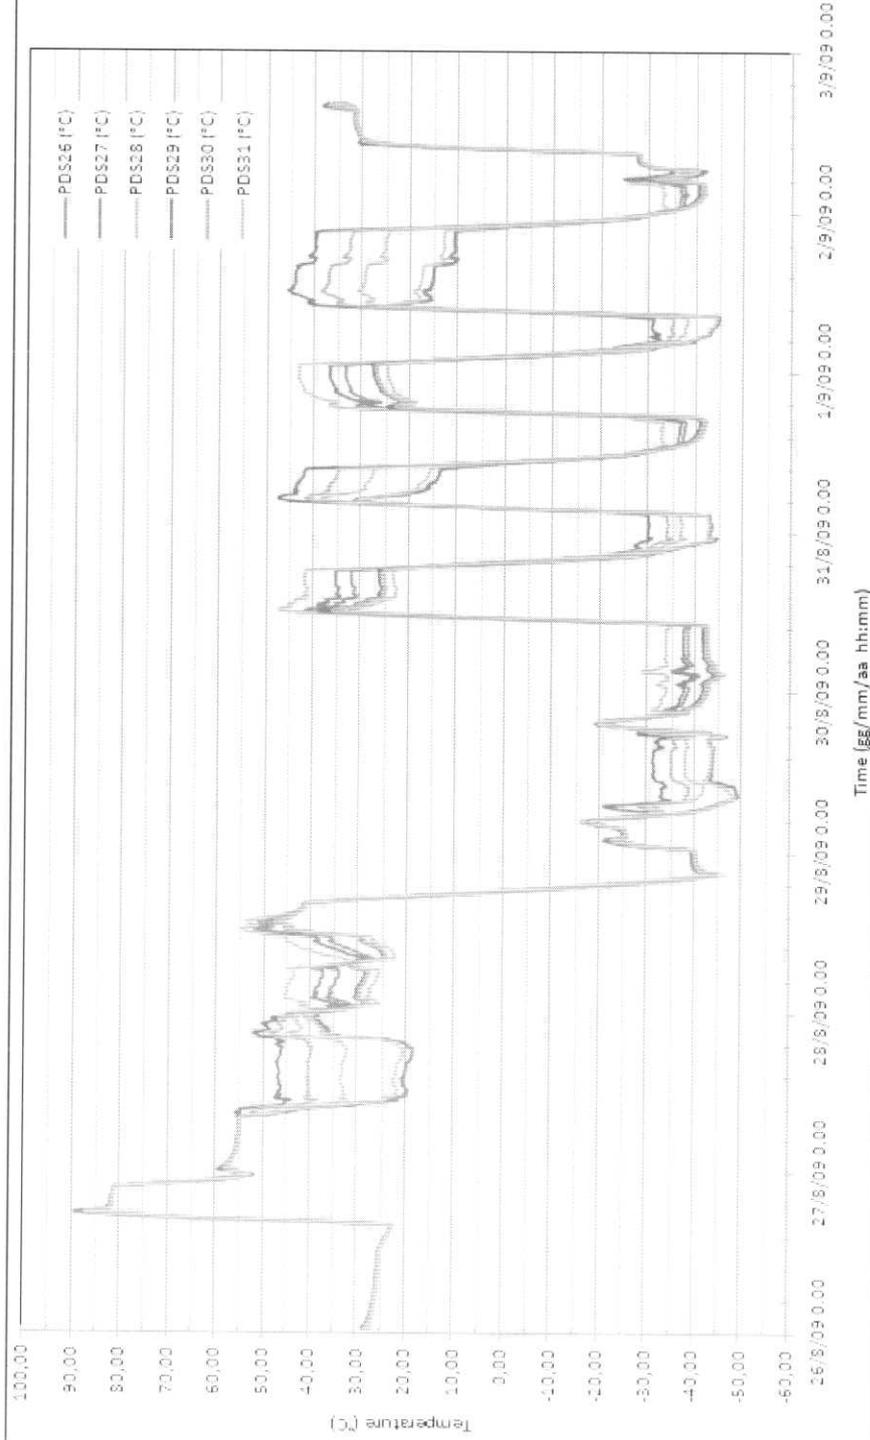
FIGURE 38 – PDS IF PLATE TEMPERATURE PROFILE.

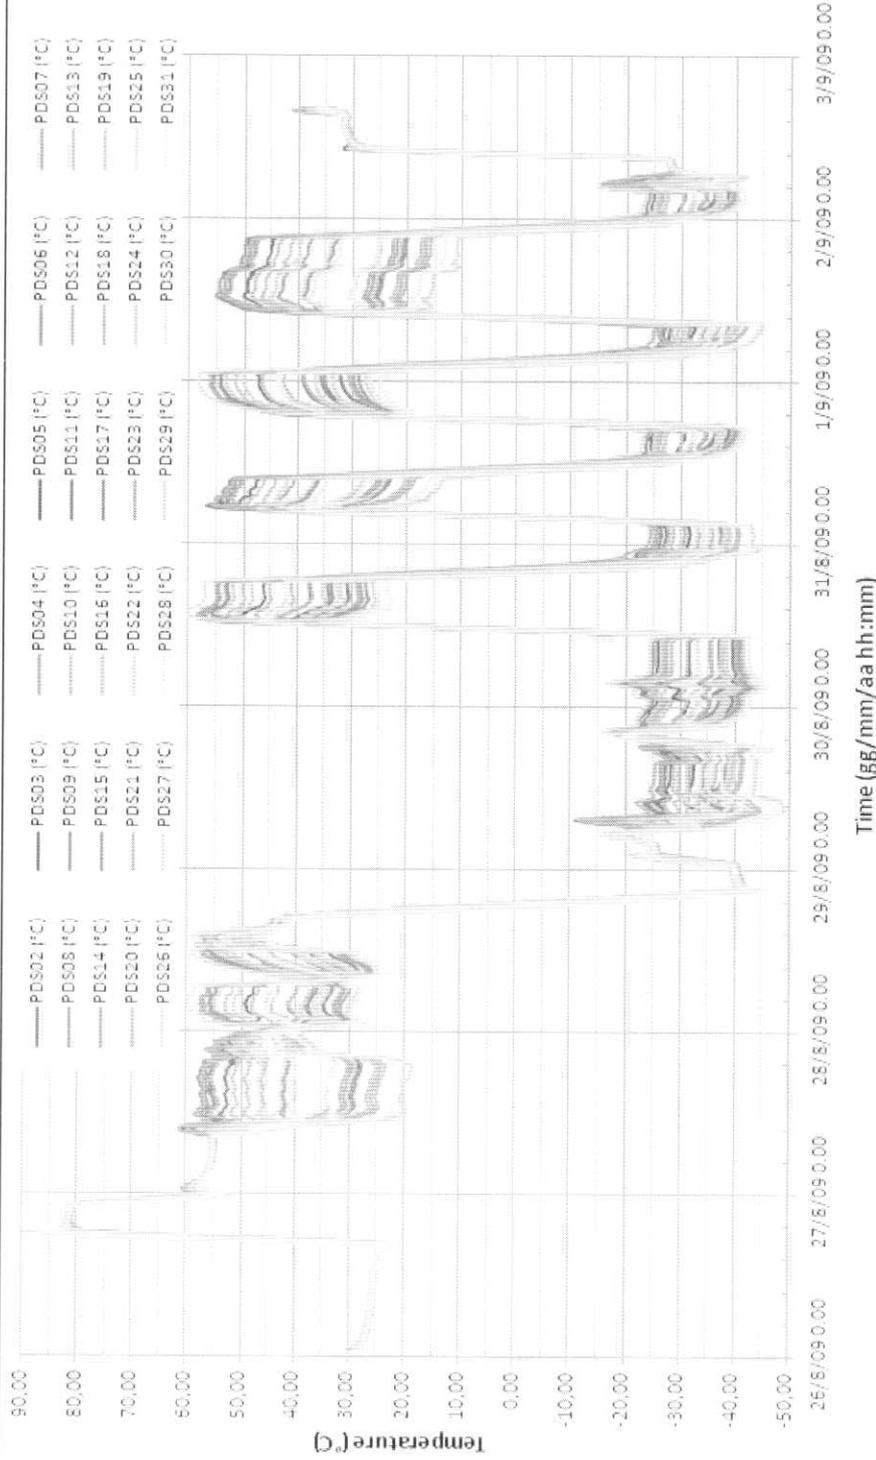
FIGURE 39 – ALL PDS SENSORS (N°31 PT100) TEMPERATURE PROFILE.
